Manhole Inspection Summary

Manhole # S15AA_038MH

Insp Date: **11/14/07 4:01 PM**

Location Address: **REAR 2700 BLOCK OF LAFAYETTE ST** Cross Street: **ASHBURTON ST**

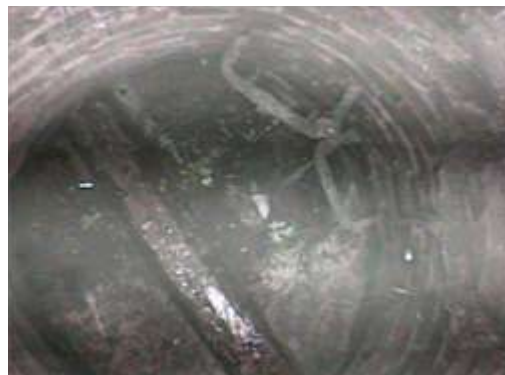
Defect 1

Steps Count: **6** Missing: **0** ☒ **Corroded**

CORRODED STEPS

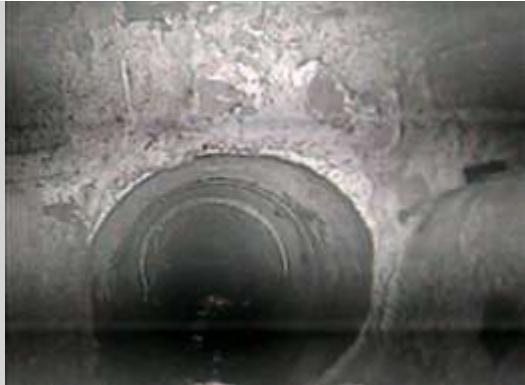
12 O'Clock Outflow

8 in. Circular Gravity Sewer
Pipe Out @ 12 O'Clock

CORRODED STEPS

Invert Depth: **9.71** (ft.) Flow Characteristics: **Slow**

Infiltration: **None** Pipe Seal Cond: **Sound**

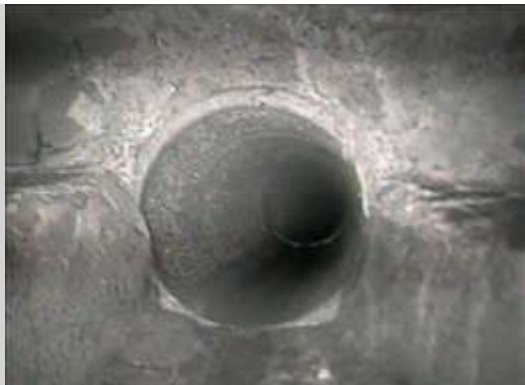
6 O'Clock Inflow

8 in. Circular Gravity Sewer
Pipe In @ 6 O'Clock

CORRODED STEPS

Invert Depth: **8.76** (ft.) Flow Characteristics: **Slow**

Infiltration: **None** Pipe Seal Cond: **Sound**
